Manufacturability Report Bandwidth Board

Analog Technologies Corp.

Summary:

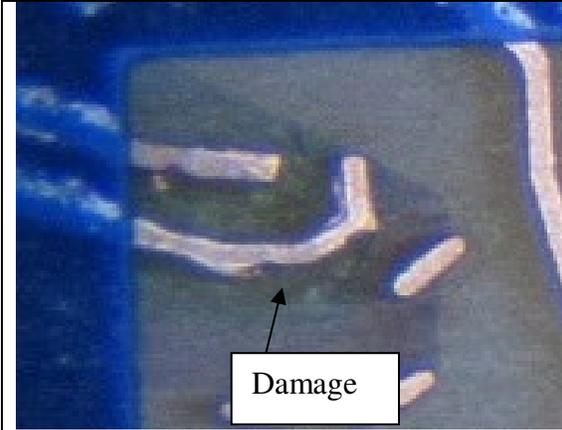
Trace etching – Trace etching was an issue in the case of both under- and over-etching. Under-etched areas appear to have been manually cut, leaving inconsistent trace widths and damaged solder ball lands. Over-etched areas resulted in ultra thin land areas for attachment.

Under-etched area that was manually modified resulting in compromised traces

Please feed this back to the PCB fabricator. With tight process control and best practices, board houses are consistently achieving these lines and spaces. The board vendor may have to look at their internal process to see what adjustments they can make. They may have some ideas for design practices that working in conjunction with their processes can minimize these types of anomalies. For example, based on the above photographs, one might suggest that if there is a constant mask boarder without nearby via features that affect the mask geometry, the plating chemistry intrusion can be reduced significantly.

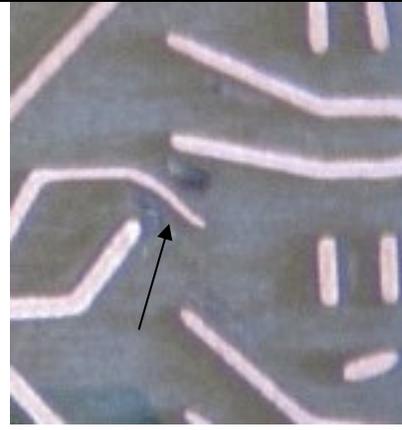
Over-etched area, trace too thin where solder sphere lands

Many of the traces on in the flip chip area are over etched. This ultimately affects the collapse of the chip during processing and reliability.

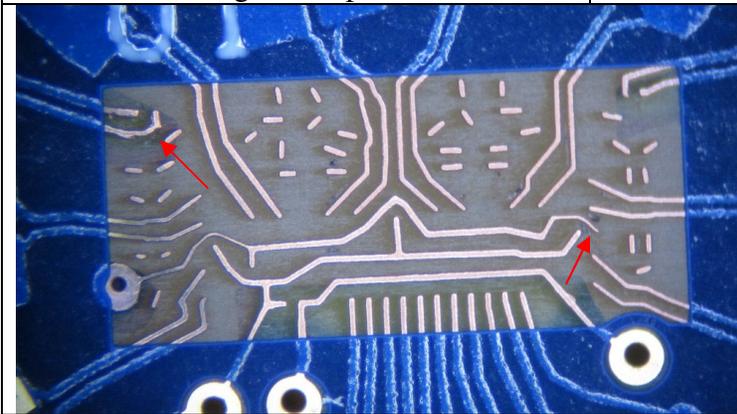
Further evidence

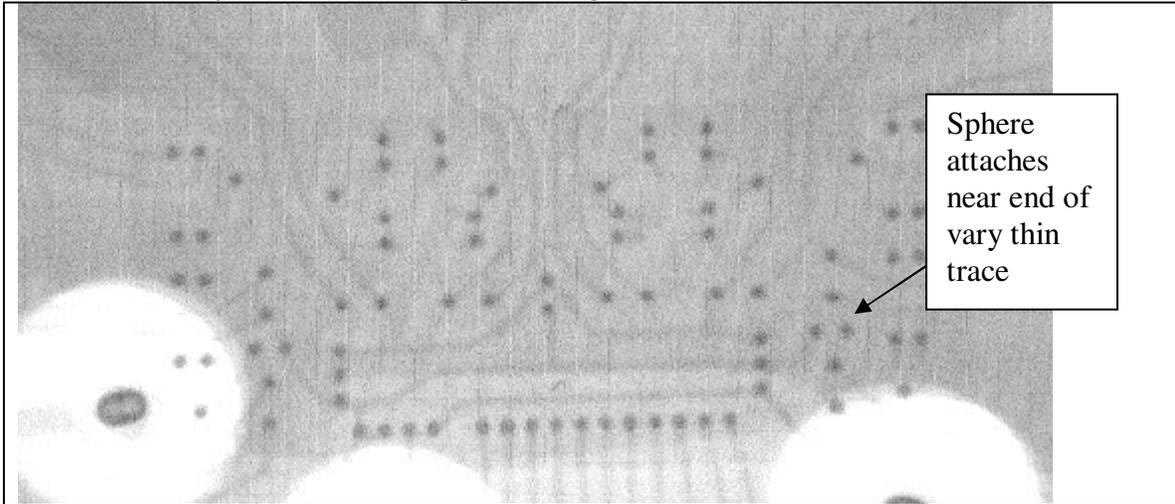
Here is an X-ray of the solder ball positioning – not reflowed

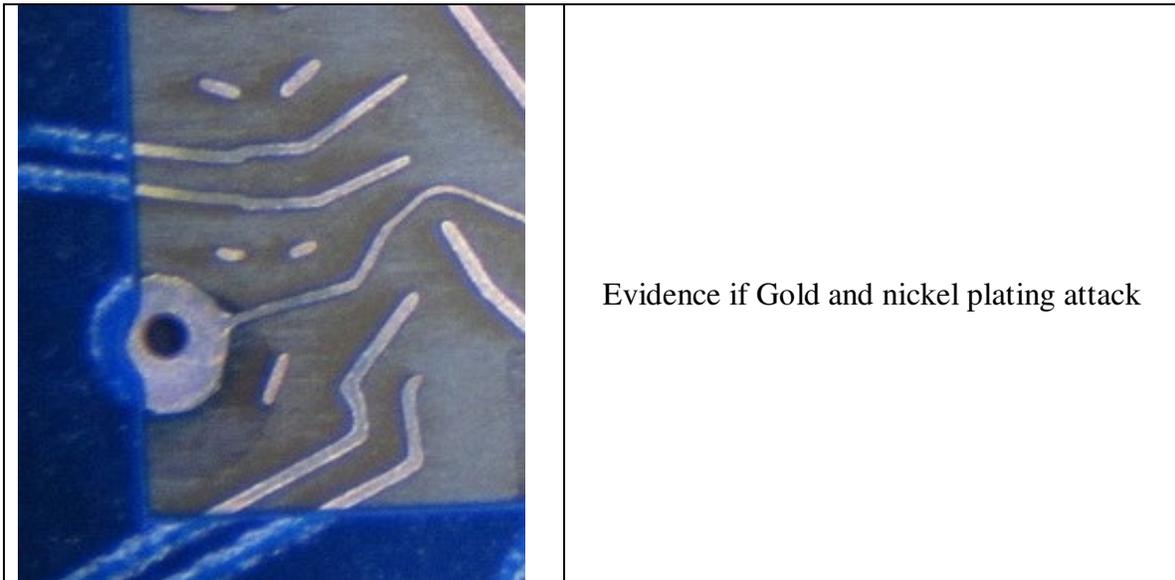
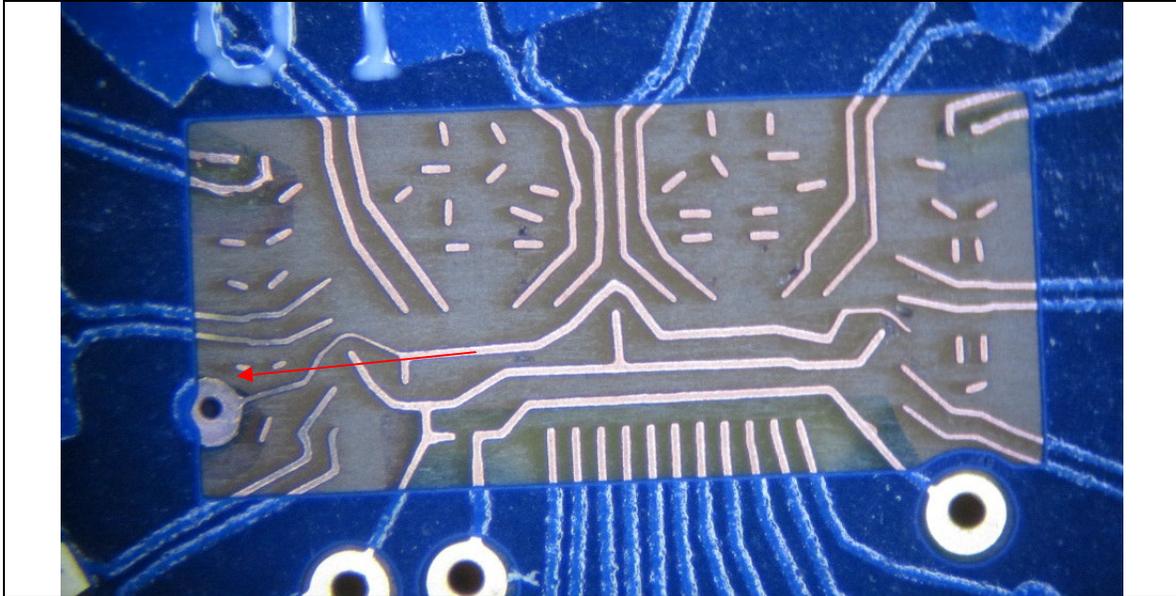
Plating – The gold plating process appears to have undesirable side affects could impact flip chip attachment. There appears to be some attack on the flip chip copper that is occurring during nickel or gold plating. Several traces appear to be discolored in the flip chip area. There are typically two sources for discoloration in the flip chip area. If the OSP coating is too thin or has degraded, the copper traces can oxidize. Secondly, if the plating chemistry reacts with the copper during gold and nickel plating processes, the attachment lands for the flip chip can be affected. This is especially true if the surface of the copper is compromised in such a way that the solder spheres cannot properly wet or form intermetallics with the surface.

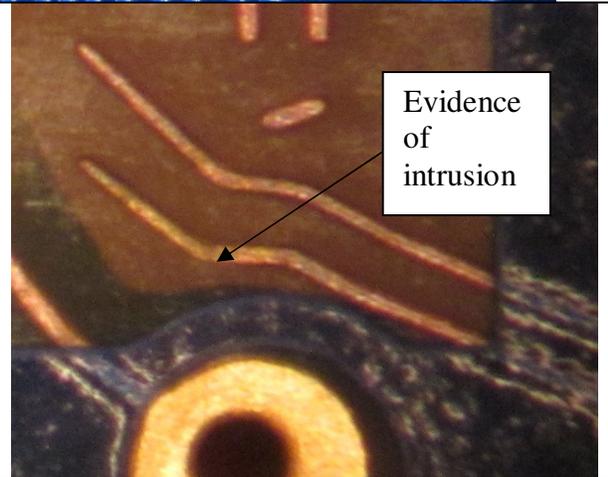
Plating penetration evidence from a second board. The plating chemistry intrusions appear to be in areas where the solder mask geometry is not consistently flat and straight.
