Manufacturability Report Bandwidth Board

Analog Technologies Corp.

Summary:

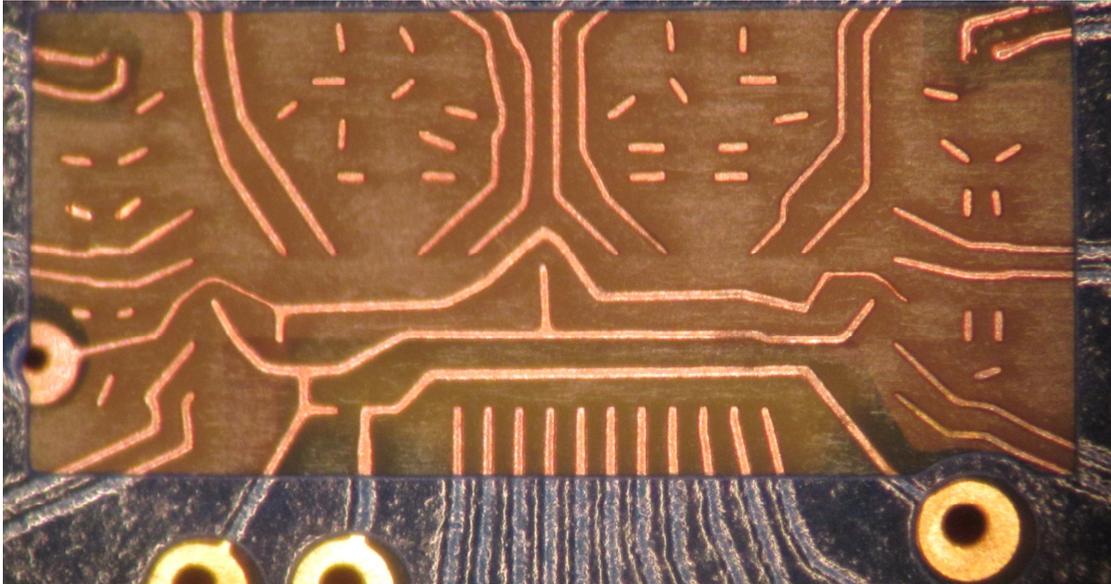
ATC has been providing incoming inspection feedback on several quick-turn boards provided by XXX. This report will summarize the findings for printed circuit board number 11TC0548 PCB (ATC 36387). This bandwidth circuit board is approximately 5"X8" with a single flip chip mounting location centered approximately 1/3 from then end of the board. The board is gold plated with exception of the flip chip area which is selective OSP coated. This board displayed several issues in the flip chip area that could have been deemed rejectable. In order to meet production demands, these boards were processed. The underlying issues need to be addressed at the design and/or fabrication level. The trace width and spacing requirements would make this board understandably difficult to fabricate.

Photo of a flip chip area
